NO.	REV. NO.
ATM-1093	
PAGE <u>1</u>	OF <u>6</u>
DATE

Array E S-Band Compatibility  
Test Results Analysis

Abstract

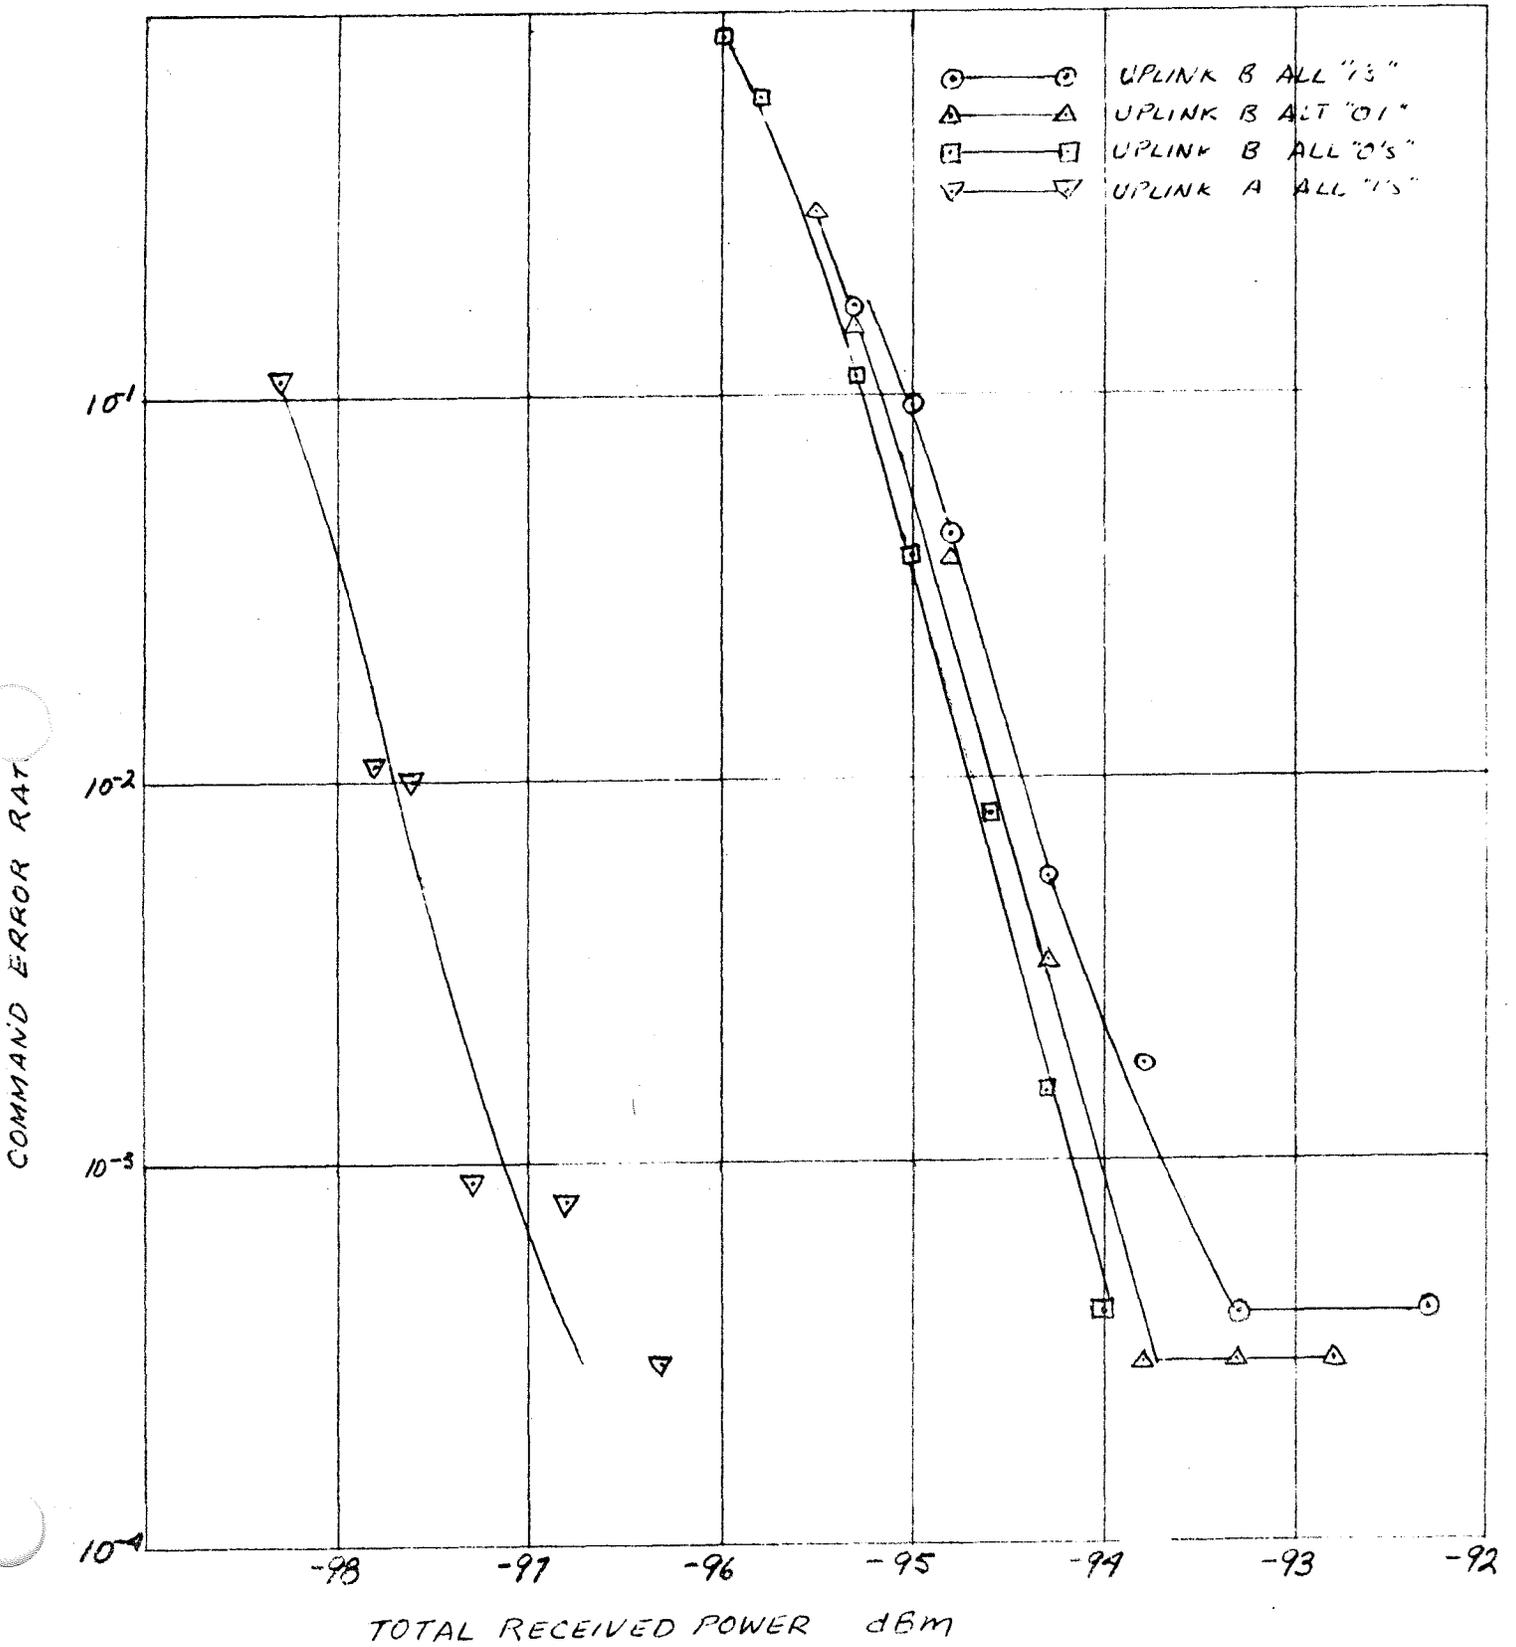
COMMAND ERROR RATE  
AS A FUNCTION OF TOTAL RECEIVED POWER

Figure 1, curves of command error rate as a function of total received power, was plotted from the MSFN/ALSEP compatibility test data. First it should be noted that the system does meet the specification limit of one command error in  $10^3$  at the minimum predicted signal level of -92 dBm. The second point of interest is the fact that as the received power was increased to a level where the measured bit error rate went to zero, the results still indicated that three (or four) out of 10,000 commands were not executed. In fact the curves of Figure 1 indicate that a further increase in received power would not result in a reduction in command errors.

As further background, it was noted during these tests that there were three command errors for the case of no bit errors if 1000 or 10,000 commands were transmitted. This indicates that the command errors were not occurring randomly in the test sample but were systematic and most probably occurred at the beginning of the test run. With no further knowledge it is possible to suspect either the MSC test set up or the ALSEP uplink. However, thorough analysis of the Command Decoder circuitry by both Bendix and MSC personnel failed to uncover any mechanism for failure to execute a command when an error free bit stream is delivered to the command decoder. Furthermore, during DVM and Qual model testing, thousands of commands have been transmitted to Array E ALSEP with no indication of systematic rejection of commands. Finally,

an independent uplink test was run at BxA using the Pre Flight Model Command Decoder (See AER 489). This model had been updated to final circuit configuration including all modifications to the control logic. The test was performed in conjunction with an ALSEP receiver (SN-13), similar to the compatibility test at MSC for a single received power level of -92 dBm. Approximately  $9.75 \times 10^3$  commands were transmitted during this test with 100% command execution and no loss of CVW. Based on circuit analysis and these test results, it is the BxA opinion that the difference in the count between commands received and commands transmitted measured during the MSFN/ALSEP compatibility test, when no bit errors were detected, is due to the operation of the MSC test set up and not due to improper operation of the ALSEP Command Decoder.
