**Aerospace
Systems Division**

NO.	REV. NO.
ATM-1055	
PAGE <u>1</u>	OF <u>6</u>
DATE 8 Sept 1971

A2 HFE DH15 ANOMALY INVESTIGATION

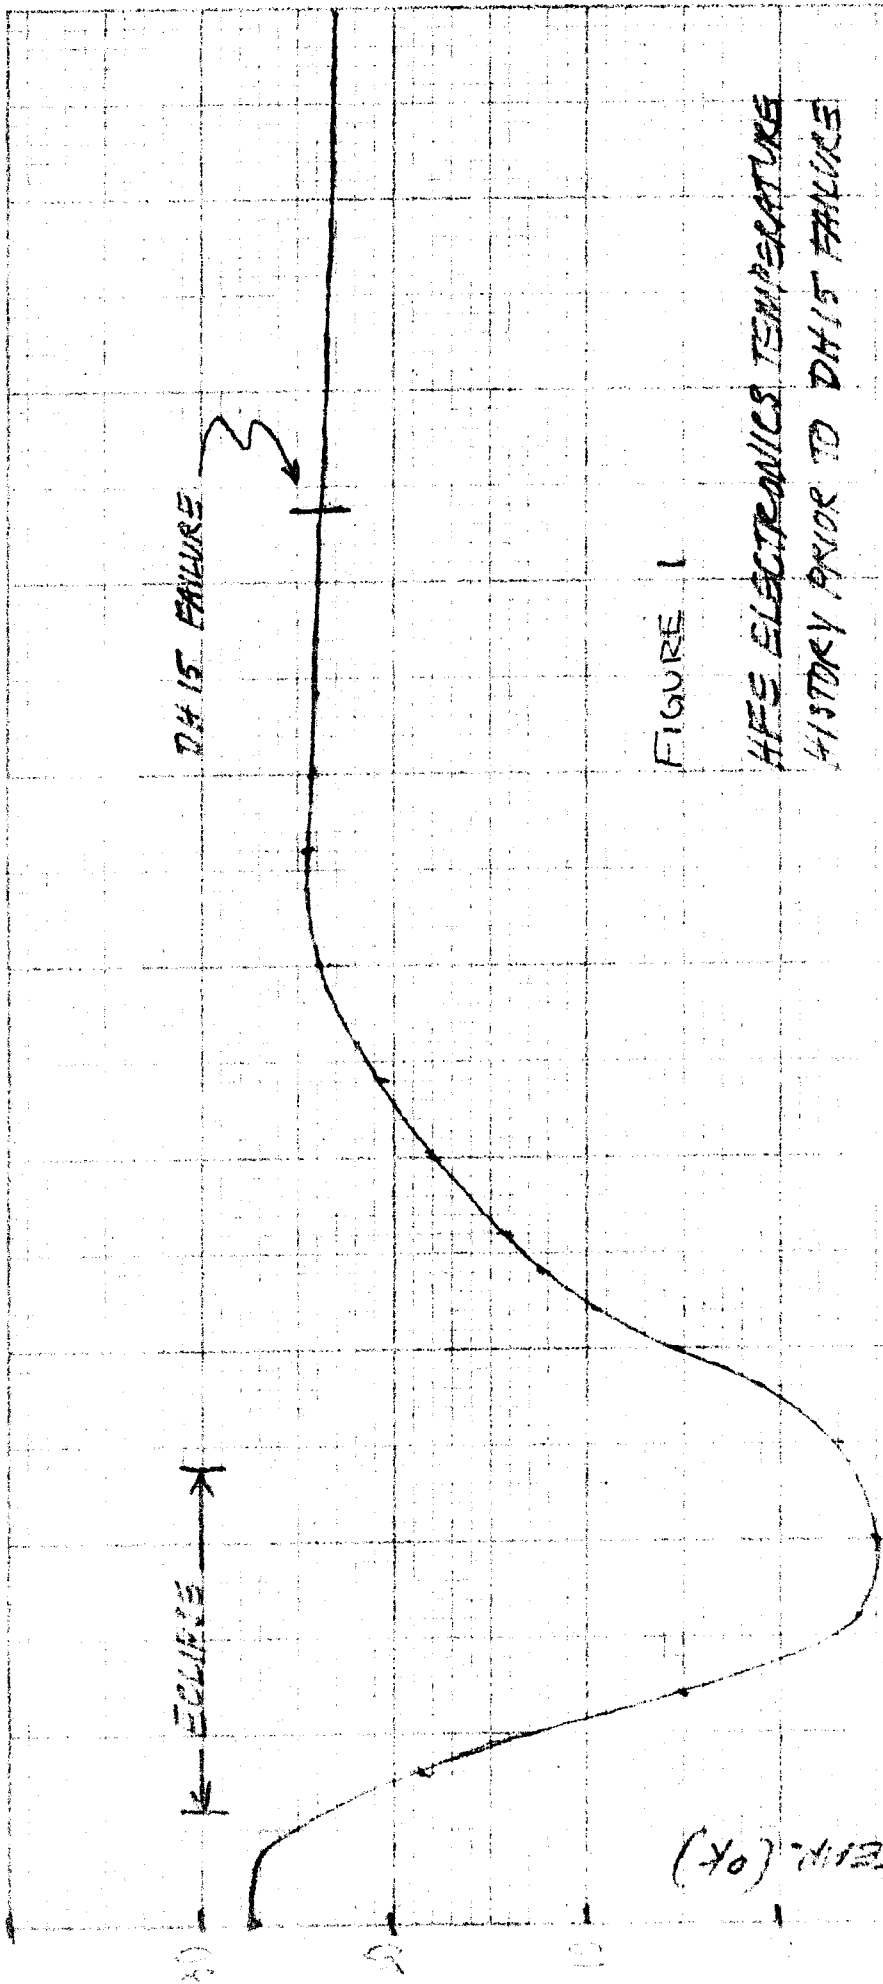
FIGURE 1

Since 219/10/27/56 EGMT, data from A2 HFE probe 2 thermocouple reference bridge Channel DH15 (DH91=1110) has exhibited symptoms that indicate a possible failure within the HFE electronics. At the above time the electronics temperature had been stabilized for over four hours following the August 7th eclipse. This is shown in Figure 1.

HFS ELECTRONICS TEMPERATURE HISTORY PRIOR TO DH 15 FAILURE
