**Aerospace
Systems Division**

APOLLO 14 DRT INSTALLATION
ANOMALY STUDY

NO. ATM-997	REV. NO.
PAGE <u>1</u> OF <u>8</u>	
DATE

This ATM is being issued to summarize the results of the anomaly study instigated as a result of the Apollo 14 problem with Dome Removal Tool insertion on the Fuel Cask Body Release Assembly.

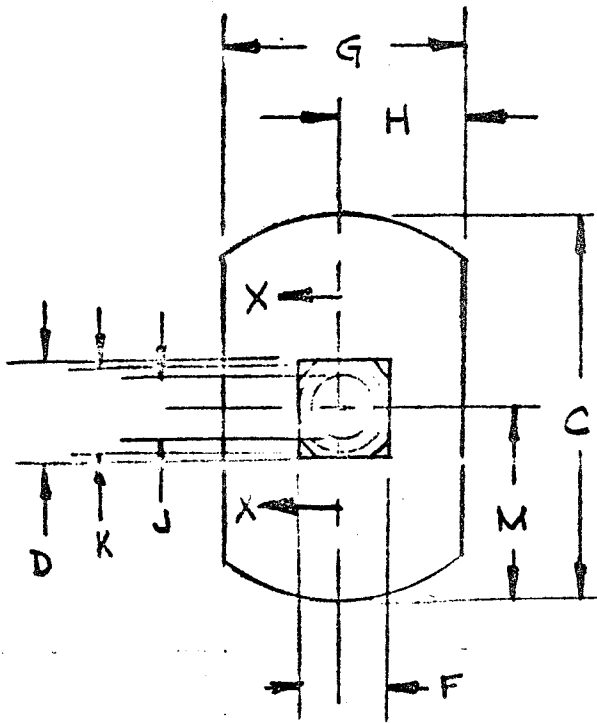
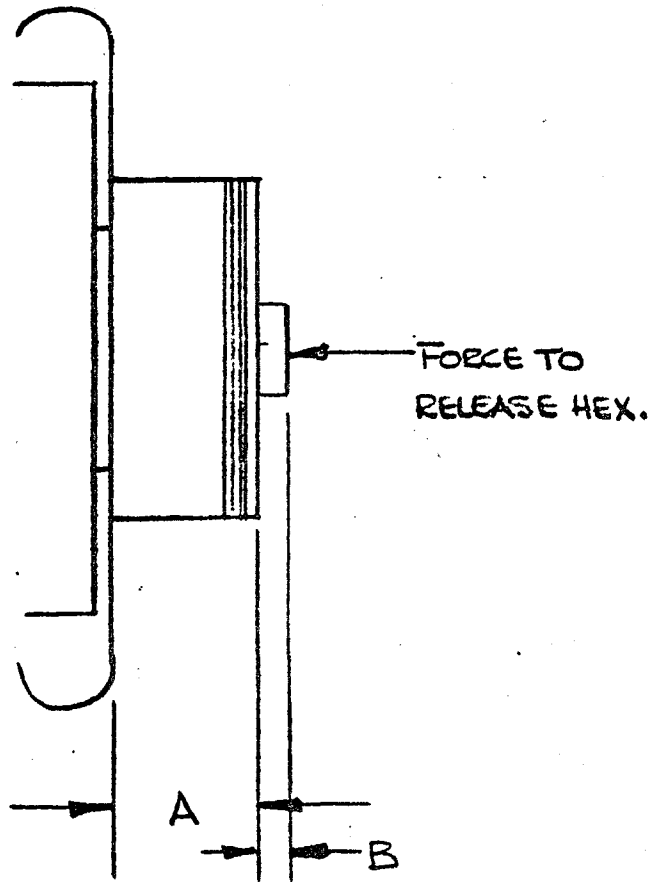
MODEL No S/N6
FLIGHT

- a. All dimensions taken are within print requirements.

A	<u>.570</u>
B	<u>.120</u>
C	<u>1.526</u>
D	<u>.401</u>
E	<u>N/A</u>
F	<u>.400</u>
G	<u>1.135</u>
H	<u>.534</u>
J	<u>.254</u>
K	<u>.374</u>
L	<u>.306</u>
M	<u>.743</u>
FORCE	<u>7.5-8.0#</u>

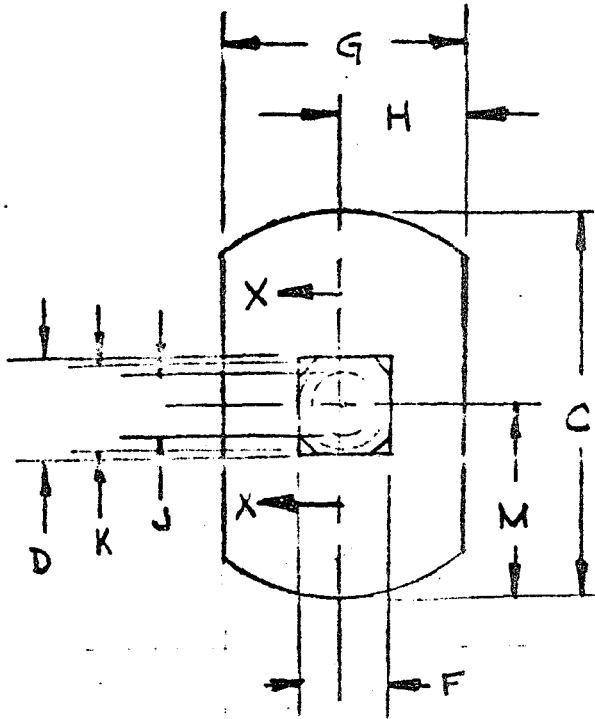
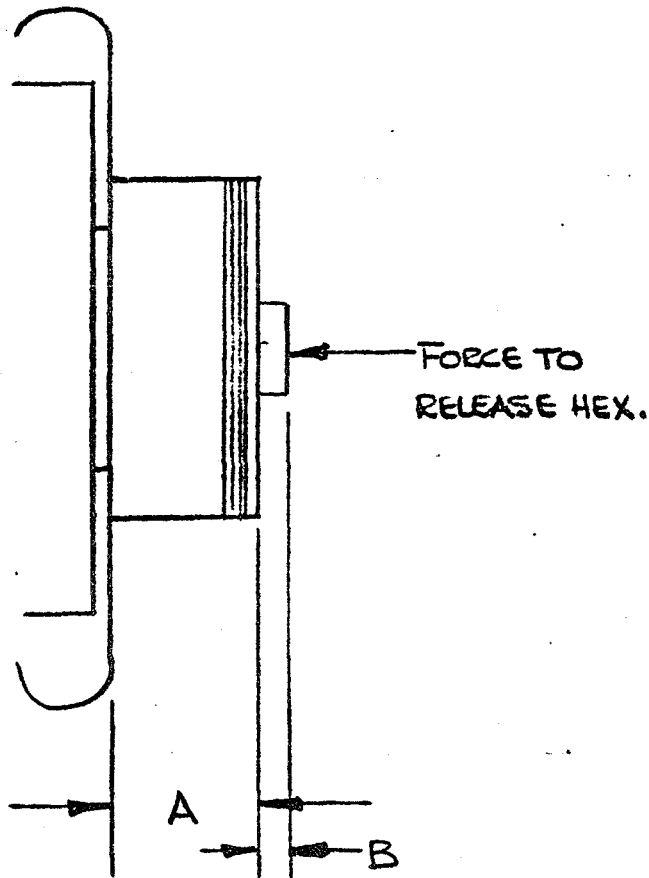
MODEL No S/N8
FLIGHT SPARE

A	<u>.563</u>
B	<u>.128</u>
C	<u>1.509</u>
D	<u>.400</u>
E	<u>N/A</u>
F	<u>.400</u>
G	<u>1.137</u>
H	<u>.557</u>
J	<u>.253</u>
K	<u>.250</u>
L	<u>.282</u>
M	<u>.743</u>
FORCE	<u>7.0-7.2#</u>

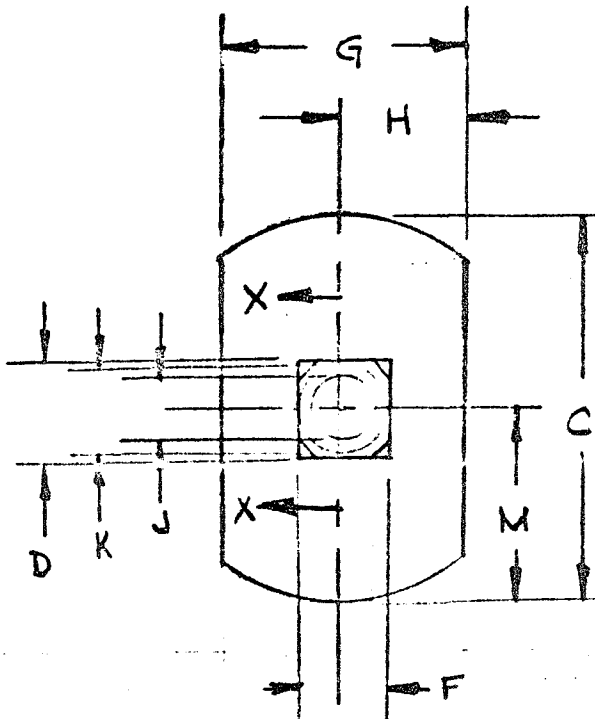
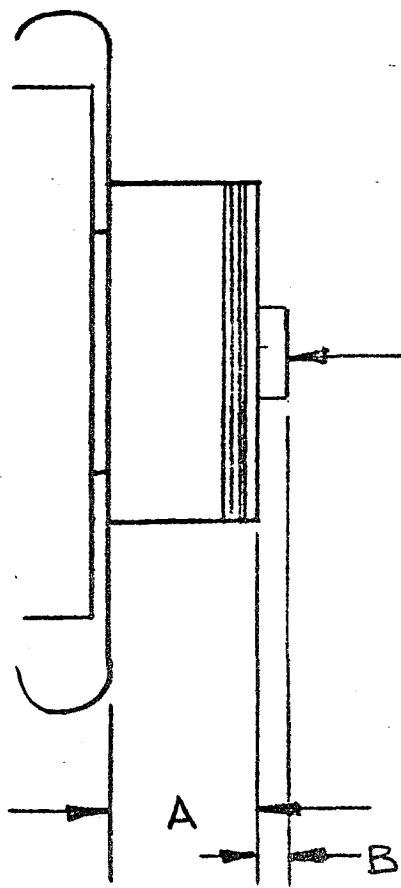
MODEL No KSC TRAINER

- a. The dimensional checks that were made are shown in attachment I with the out-of-tolerance item circled.
- b. The spline lock is a metal pin rather than the ceramic bead string.
- c. The GLFC dome holes for alignment of the Body Release Assembly are extremely oversize, elongated and broken out.
- d. The Body Release Assembly had several discrepancies above and beyond those noted on the dimensional check:
 - (1) The assembly is an aluminum construction.
 - (2) The release levers are badly worn.
 - (3) The angle brackets are full slotted per design but are badly worn.
 - (4) The positive stop appears to have rewelded.
 - (5) The angle brackets have been broken off and re-assembled to the bands.
 - (6) The plunger is badly worn and deformed (both internally and externally).
 - (7) As reflected in the dimensional check the spring force is extremely low.

A	.572
B	.120
C	1.503
D	.403-.405
E	N/A
F	.401-.406
G	1.125-1.135
H	.552
J	.255-.257
K	.379
L	.282
M	.743
FORCE	4.5-5.0#

- A. It was agreed at a meeting with J. Briley, NASA/MSC that the KSC Trainer should be considered the prime training hardware consisting of the best possible components.
- B. The aluminum body release assembly on the KSC Trainer should be replaced with a new titanium assembly.
- C. The titanium body release assembly on the MSC Trainer should have piece part replacement in the area of the DRT interface.
- D. The non-conforming wire spline lock on the KSC Trainer should be replaced with proper ceramic bead construction.
- E. The Norco lock assembly of the Trainer DRT should be replaced.
- F. An astronaut decal should be added to the DRT to reflect the off-set requirement for engagement.

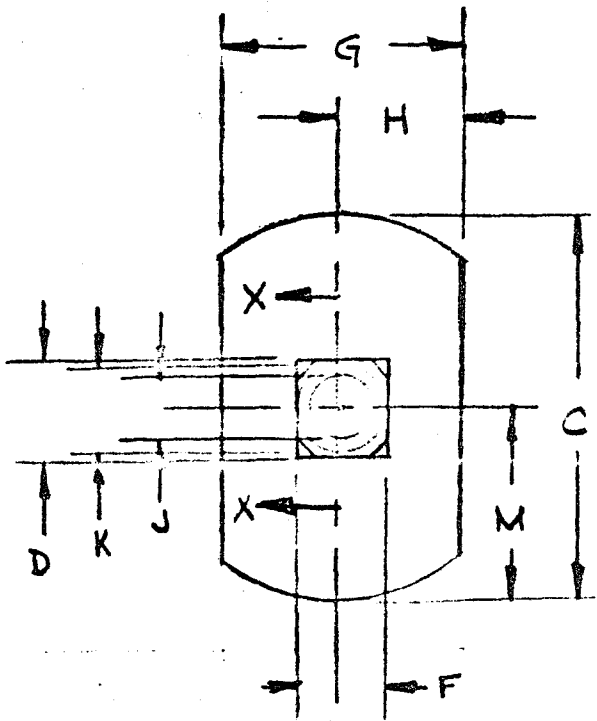
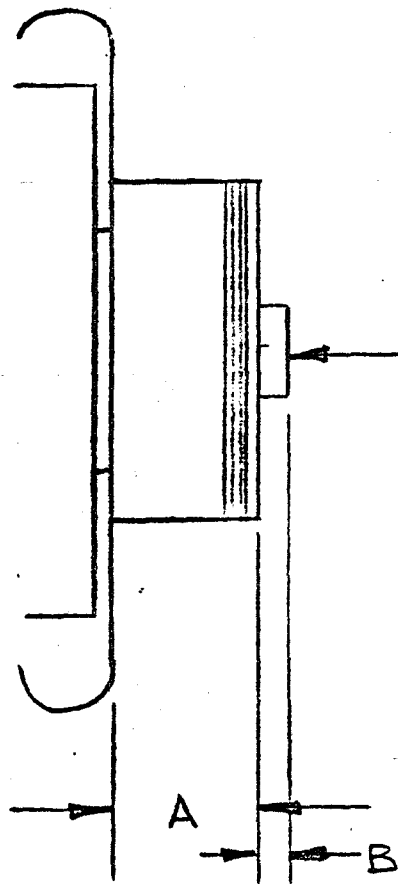
MODEL No MSC TRAINER

- a. The dimensional checks that were made are shown in Attachment II, with the out-of-tolerance items circled.
- b. The Body Release Assembly had several discrepancies above and beyond those noted on the dimensional check:
 - (1) The locking assembly is free to rotate without depressing the plunger.
 - (2) The locking plate is badly worn.
 - (3) The plunger is badly worn and distorted (both internally and externally).
 - (4) As reflected in the dimensional check the spring force is very low.

A	<u>.578</u>
B	<u>.112</u>
C	<u>1.508</u>
D	<u>.405</u>
E	<u>N/A</u>
F	<u>.403</u>
G	<u>1.132-1.134</u>
H	<u>.554</u>
J	<u>.253-.257</u>
K	<u>.378</u>
L	<u>.308</u>
M	<u>.746</u>
FORCE	<u>5.2-5.5#</u>
